**Damaged Cupholder Mechanism –
Replace Mechanism Only –
Repair Procedure**

MODEL
1997 MY-ON XK8 Range
1998 MY-ON V8 Sedan
VIN
001001-ON
812256-ON

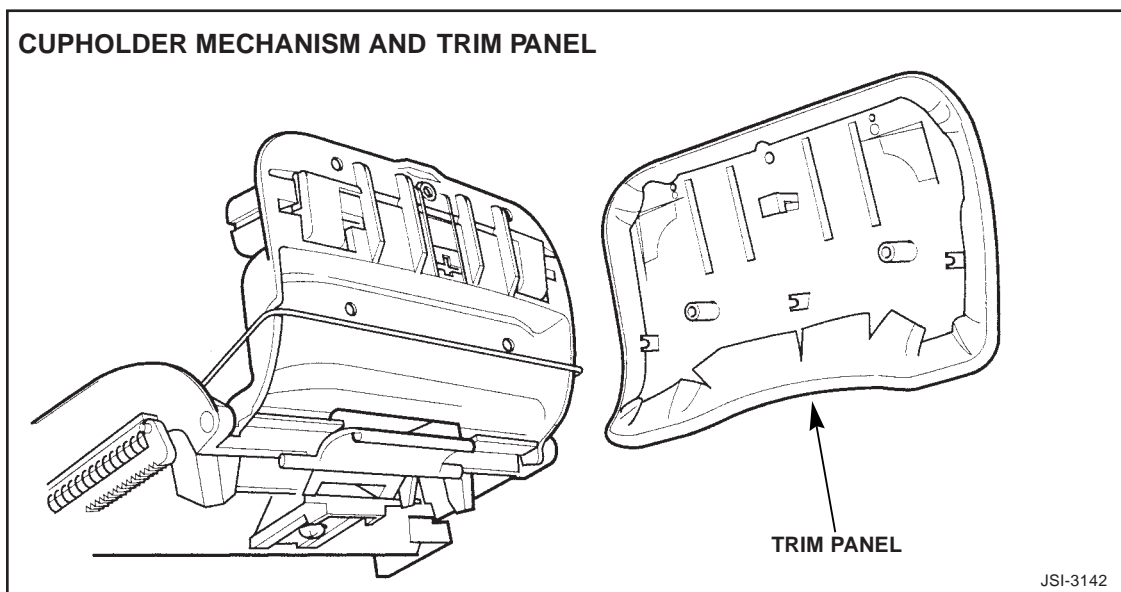
ILLUSTRATION 4

CUPHOLDER MECHANISM AND TRIM PANEL

Note: The trim panel is released by pulling the bottom edge out a little and then pushing upwards, to disengage the hooked projection on the rear of the trim pad from the mechanism.

7. Discard the damaged mechanism.
