XJ204-S516

TECHNICAL BULLETIN

**Spare Tire Speed Restriction Label –
Lack of Adhesion –
Service Action S516**

MODEL 2004 MY
XJ range
VIN Refer to VIN list

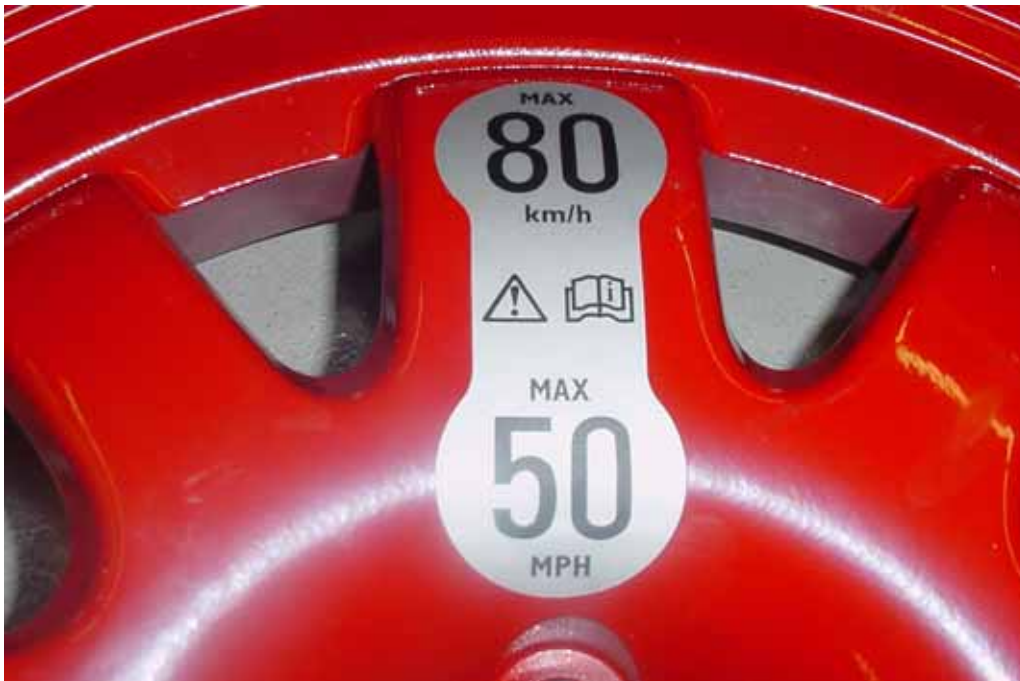
ILLUSTRATION 1

LOCATION OF SPEED RESTRICTION LABEL

4. Remove the tee bolt securing the space saver spare wheel.
5. Remove the space saver spare wheel and place aside.
6. Remove the old speed restriction label from space saver spare wheel.
7. Clean the area of space saver spare wheel before installing the new label.
8. Install the new speed restriction label on the front face of the wheel (Illustration 1).
