Entry Of Water Into Vehicle –  
Possible Sources

MODEL 2004 MY-ON  
XJ range

VIN G00001-ON

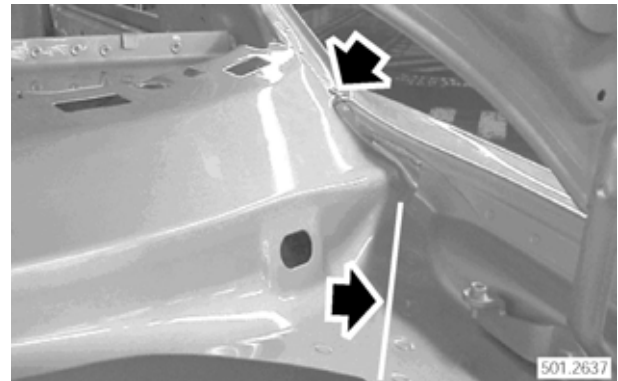
ILLUSTRATION 1

Water entering the spare wheel well causing the luggage compartment carpet to be wet towards the front of the luggage compartment.

Hole in sealer between the rear fender and bottom corner of backlight panel, or forward channel seam leaking (Illustration 1).

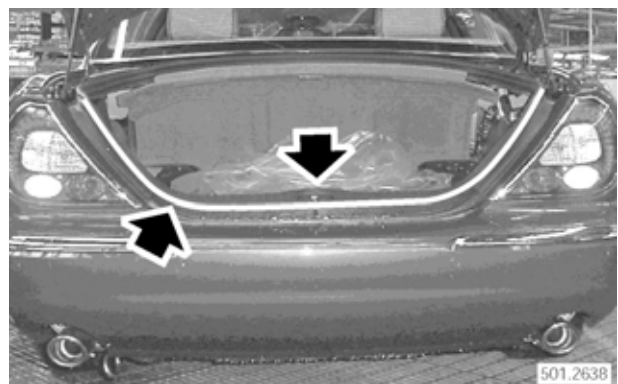
ILLUSTRATION 2

Water entering the spare wheel well causing the luggage compartment carpet to be wet.

Water tracking underneath the luggage compartment aperture seal (Illustration 2).

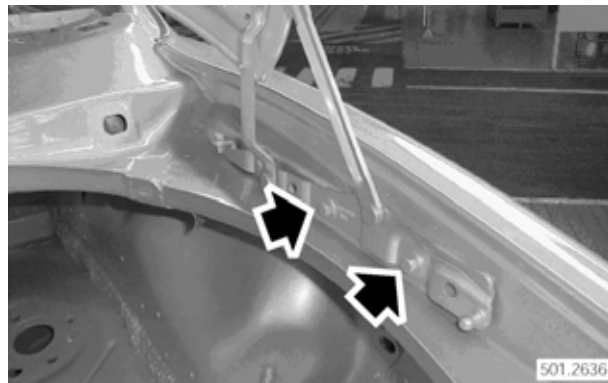
ILLUSTRATION 3

The luggage compartment carpet is wet at one or both sides.

Water ingress through luggage compartment lid hinge securing bolts (Illustration 3).

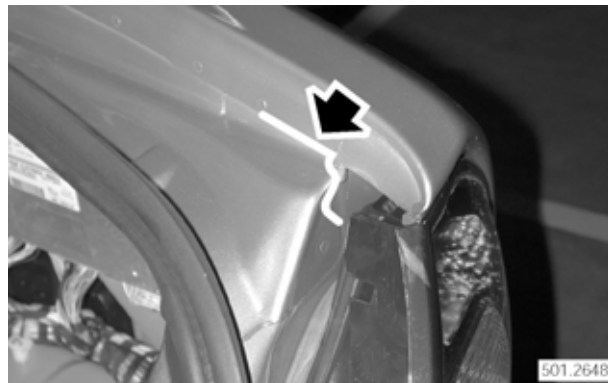
ILLUSTRATION 4

The luggage compartment carpet is wet towards the rear of the luggage compartment.

Rear fender seam leaking (Illustration 4).

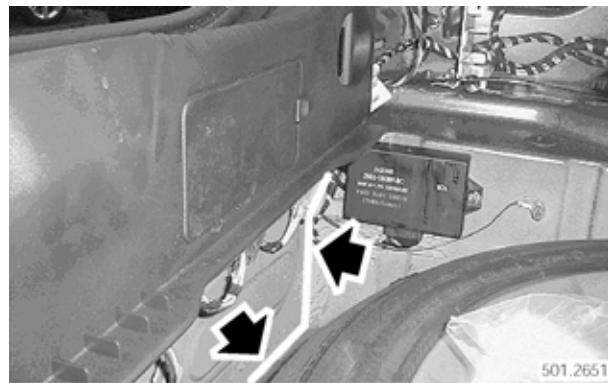
ILLUSTRATION 5

Water ingress onto the spare wheel well.

Luggage compartment floor seams leaking (Illustration 5).

**Note:** Water leak mainly from vertical part of the seam.

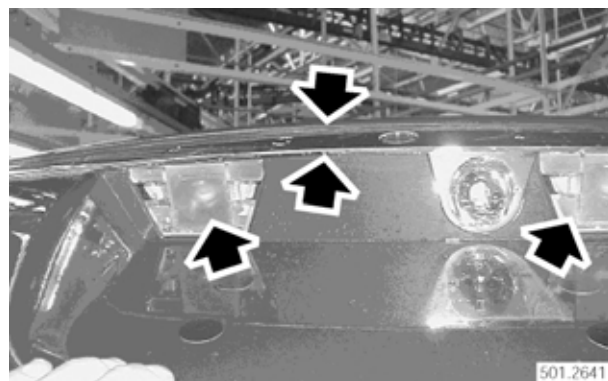
ILLUSTRATION 6

Water ingress into the rear license plate lamps.

Luggage compartment trim finisher is not correctly sealed to the luggage compartment lid (Illustration 6).

**Note:** Foam attached to finisher may be distorted.

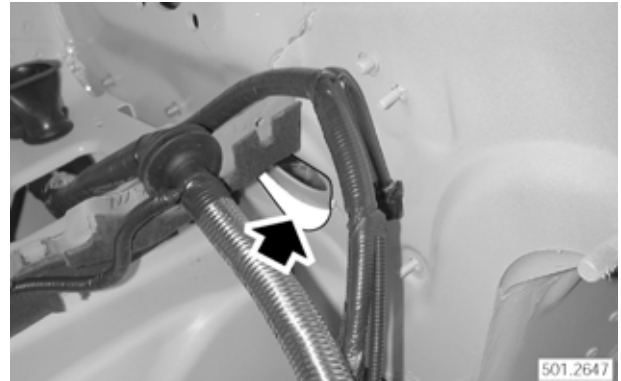
ILLUSTRATION 7

Water ingress into the driver's footwell.

Water can track between the body panels where the lower steering column exits the bulkhead.

**Note:** Apply a suitable wet sealant to the area shown (Illustration 7).

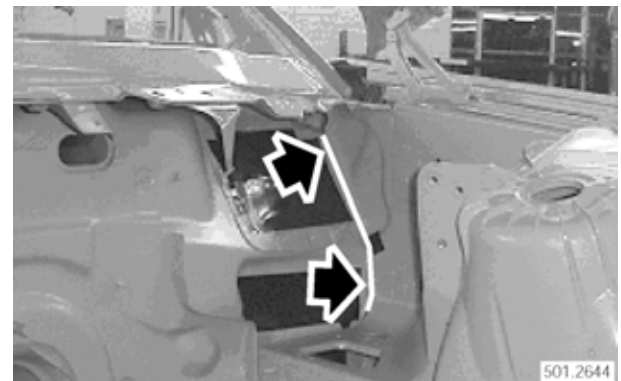
ILLUSTRATION 8

Water ingress into the front footwells.

Seams between inner front fender and bulkhead are leaking (Illustration 8).

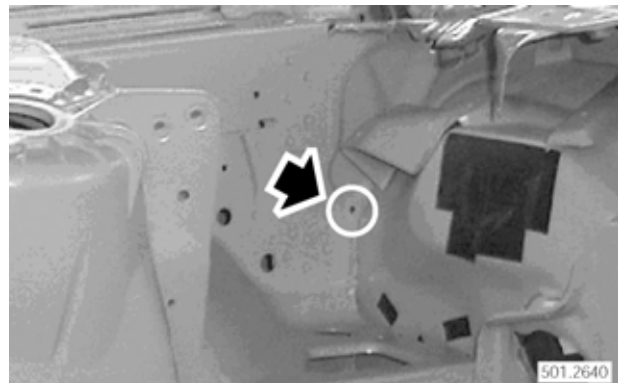
ILLUSTRATION 9

Water ingress into the front passenger footwell.

Patch over hole can leak water (Illustration 9).

**Note:** On the driver's side this hole is used to mount the plenum drain tube. On passenger side a blanking patch is installed.

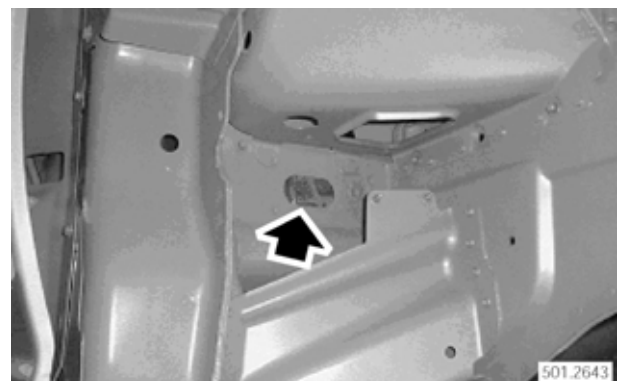
ILLUSTRATION 10

Water ingress into the front footwell.

Water ingress from harness grommet under front wheel arch (Illustration 10).

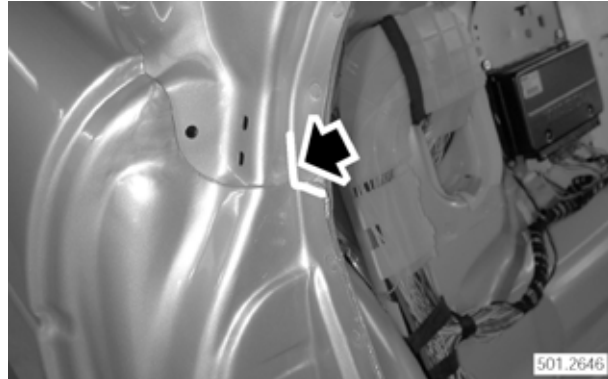
ILLUSTRATION 11

Sill carpet wet at rear.

Water tracks along joint of 'C' pillar/door shut joint under the rubber finisher, then tracks down along draft welt.

**Note:** Remove rubber finisher and apply a suitable wet sealant (to the area shown) to block the water path (Illustration 11).

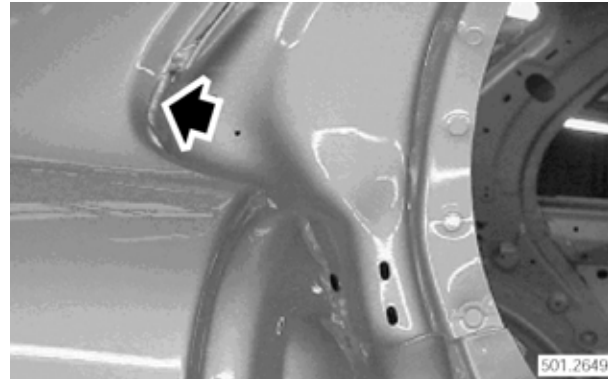
ILLUSTRATION 12

Water ingress into the cabin or boot.

Water can run from the drain channel, behind the putty, and then down onto the inner wheel arch. From here the water can run forwards into the cabin, or rearwards into the luggage compartment (Illustration 12).

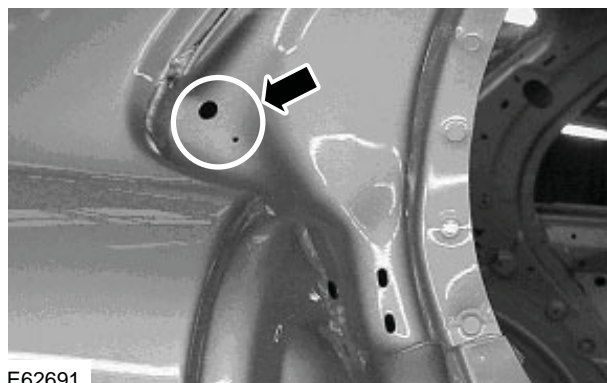
ILLUSTRATION 13

Water ingress into the cabin.

Water ingress through the drain channel finisher fixings (Illustration 13).

**NOTE:** Pull away finisher for access, remove two fixings securing the drain channel clip and apply a suitable wet sealant around the fixing holes (areas shown) to block the water path.

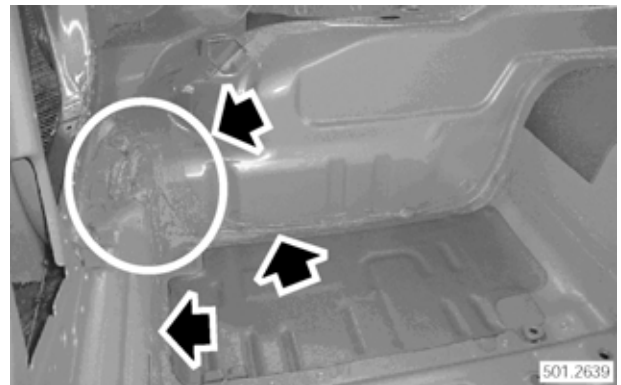
ILLUSTRATION 14

Water ingress into the rear of the cabin.

Water ingress through the seams by the rear seat (Illustration 14).

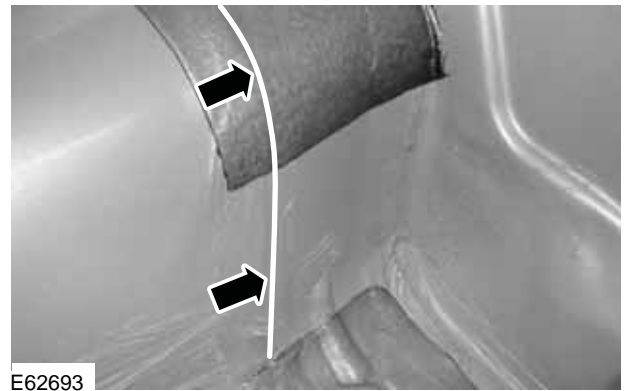
ILLUSTRATION 15

**Long Wheel Base Vehicles Only - Water ingress into the left-hand and right-hand rear footwells.**

Water ingress through the long wheel base extension seam, left-hand and right-hand side (Illustration 15).
