**Vehicle Out Of Fuel –
Range Indicated On Message Center –
Modify Transfer Pipe**

MODEL 2002 MY
X-TYPE
VIN C00001-C39700

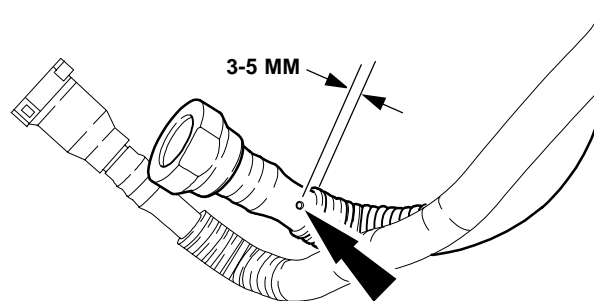
ILLUSTRATION 1

Some 2002 X-TYPE vehicles within the above VIN range, may experience a customer complaint of running out of fuel while the message center still indicates range available.

1. Remove the fuel transfer pump assembly (see Workshop Manual, JTIS CD ROM section: 310-01, SRO 19.45.06).
2. For access, reposition the return transfer pipe away from the fuel tank opening (return transfer pipe has a yellow release latch).
3. Using a 2 mm drill bit, by hand, drill a hole 3 mm to 5 mm from the shoulder (convoluted pipe side) in the return transfer pipe and remove any swarf (Illustration 1).

DRILL HOLE 3-5 MM FROM SHOULDER
