# TECHNICAL BULLETIN

## Engine Crankcase – Oil Leaks – Sealing Procedure

12-53

MODEL All V12

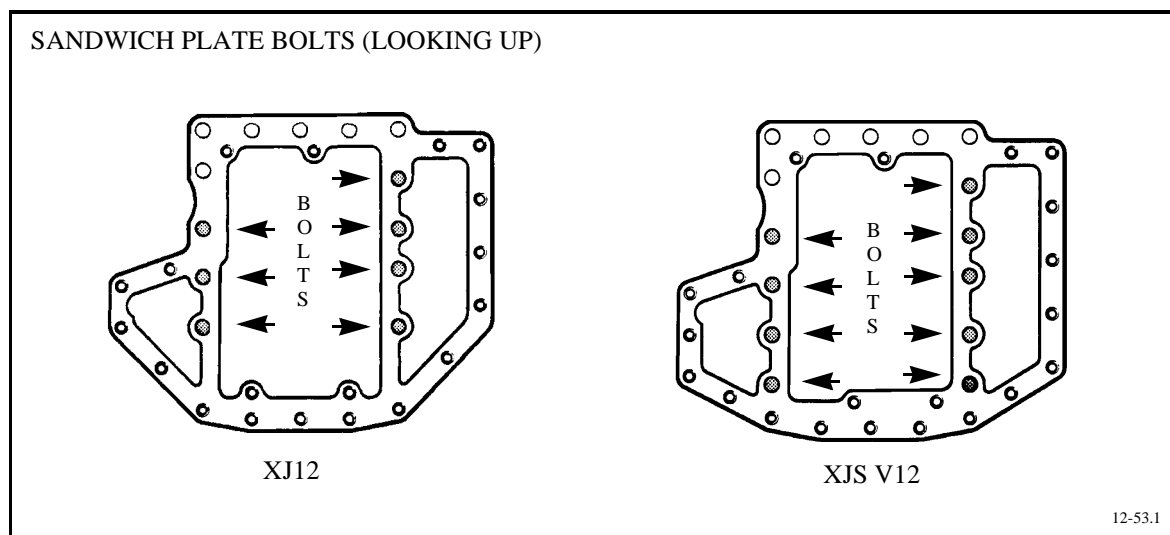
ILLUSTRATION 1

For oil leaks at the oil pan gasket or at the baffle tray and sandwich plate bolts, perform the following:

1. Remove the oil pan.
2. Remove the sandwich plate and baffle tray bolts shown in Illustration 1.
  - XJ12 - 7 bolts
  - XJS V12 - 9 bolts

3. Thoroughly clean the bolts and bolt hole threads.
4. Apply Loctite Primer to the bolt hole threads.
5. Apply Loctite 545 to the sandwich plate and baffle tray bolts. Install and torque the bolts to

16 - 20 lb ft (21 - 27 Nm).
