TECHNICAL BULLETIN

JAGUAR SERVICE	Recall T493 - 1995 MY/Recall R493 - 1996 MY – AJ16 EGR System – Replace PROMs and EGR Valve	17-12 Amended 08/02
	MODEL 1995-96 MY XJS 4.0L VIN 194775-226645	DATE 11/01

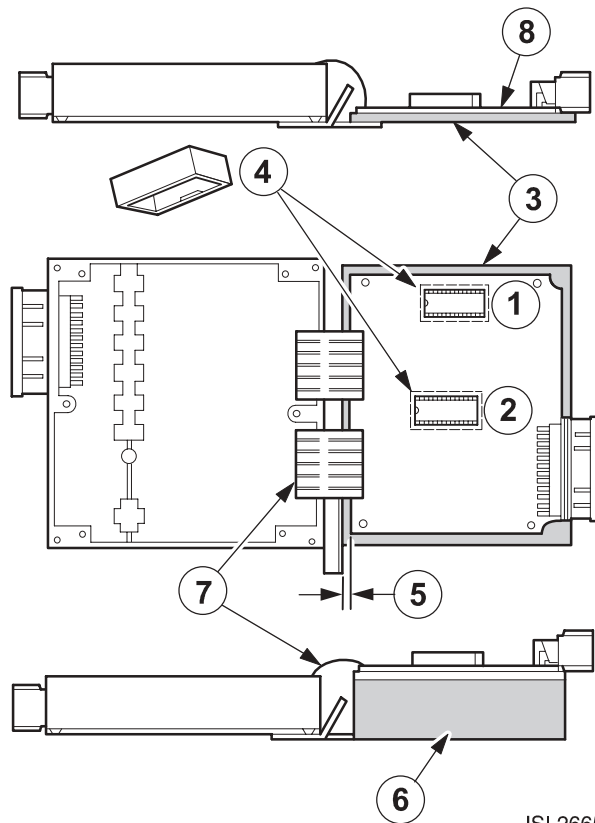
ILLUSTRATION 2

LOCATION OF PROMS IN ECM

- 1 - 28 PIN PROM
- 2 - 32 PIN PROM
- 3 - ECM COVER
- 4 - PROM COVERS
- 5 - CLEARANCE SPACE
- 6 - WOOD SUPPORT
- 7 - RIBBON CABLES
- 8 - PRINTED CIRCUIT BOARD

5. Remove the seven retaining screws of the printed circuit board (8, Illustration 2). Fold the printed circuit board away from the body of the ECM unit and support it on a block of wood (6, Illustration 2) so that no strain is placed on the ribbon connectors (7, Illustration 2). Allow a clearance space (5, Illustration 2) so that no damage can occur from contact with the mounting brackets.
6. The modification kit contains two microchips, one each of the 28-pin (1, Illustration 2) and 32-pin (2, Illustration 2) design.
7. Remove the covers (4, Illustration 2) from the microchips on the printed circuit board. Remove each cover by applying a side-to-side rocking action, gripping the cover lightly with combination pliers midway along each long side.

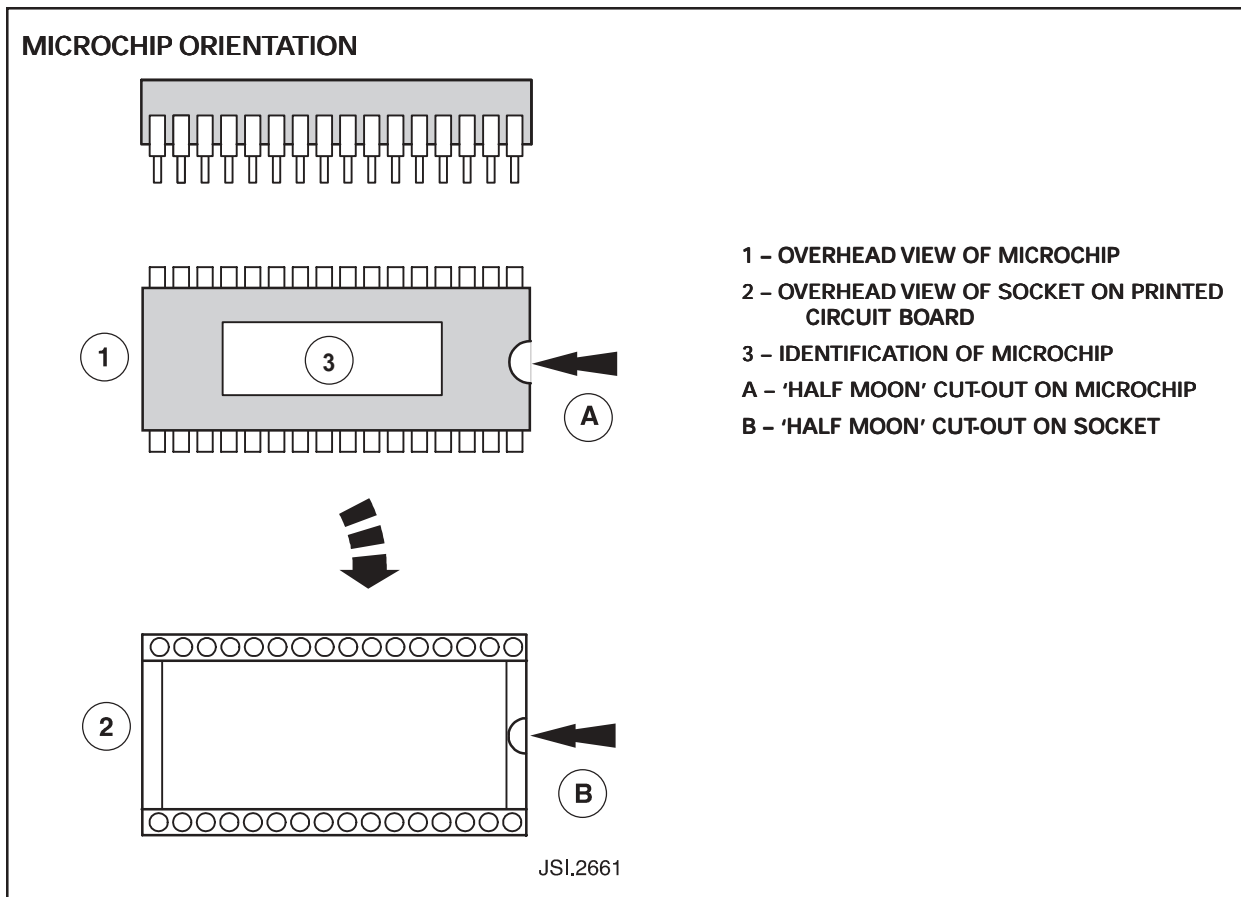
ILLUSTRATION 5

⚠ Caution: Correct orientation is mandatory. The cutouts in both items must be aligned as the microchip is inserted into the socket.

9. When inserting the replacement PROM microchips, identify the 'half moon' cutouts in both the microchip and the socket on the printed circuit board (Illustration 5).

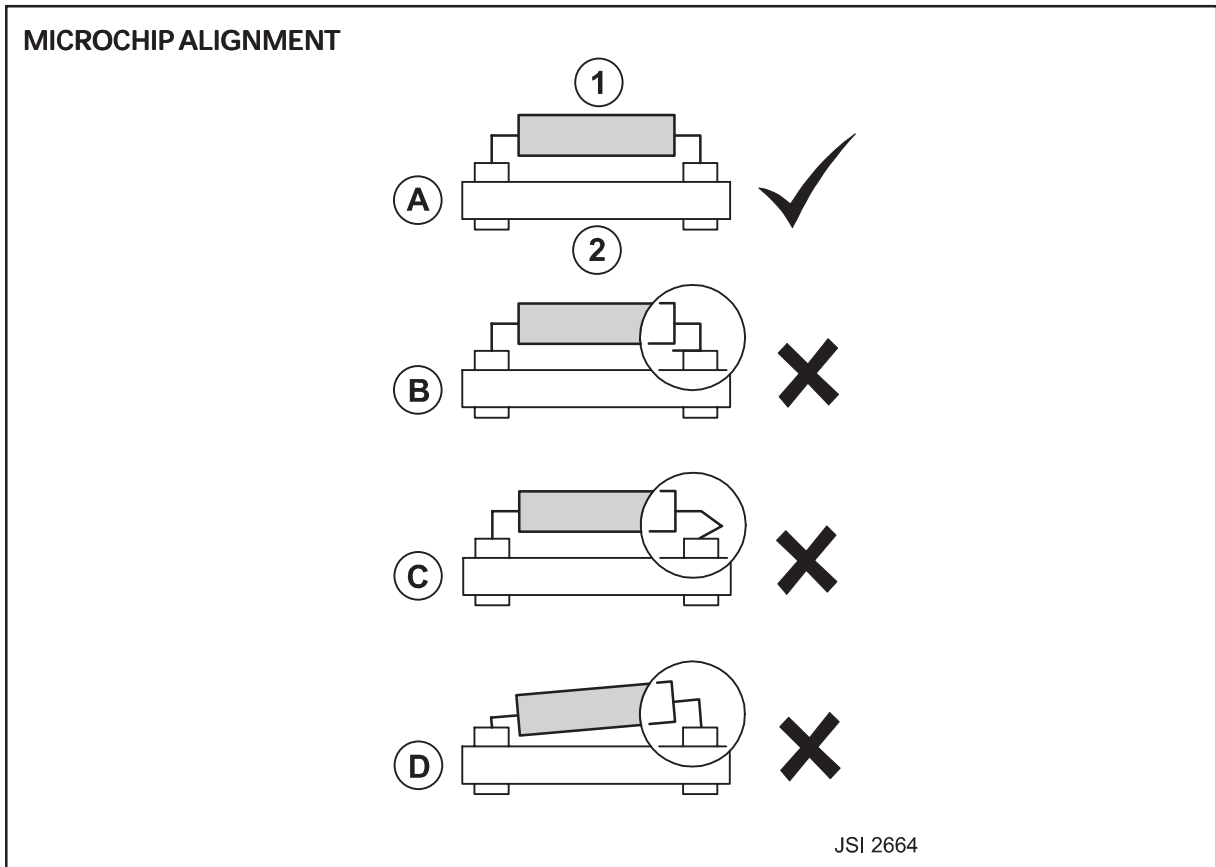
ILLUSTRATION 6

⚠ Caution: Permanent damage to the microchip is likely in conditions B or C. Malfunctions will occur with partial engagement, as in condition D.

12. Use great care to achieve condition '1' in Illustration 6. The microchip must lie parallel to the printed circuit board, with all pins fully engaged into their corresponding locations in the socket.

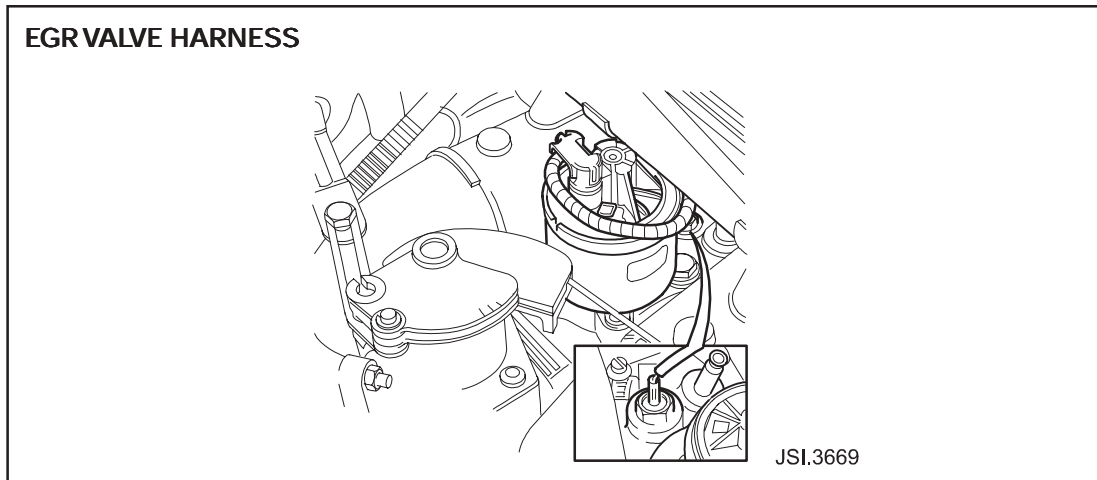
ILLUSTRATION 8

Since the introduction of the AJ16 engine Jaguar has seen a high rate of replacement of EGR valves following illumination of the malfunction indicator lamp (MIL). This is understood to be a result of accumulated contamination within the EGR valve that can produce possible drivability issues such as rough idle, hesitation, and difficult starting.

1. Open the hood and place covers over the fenders.
2. Disconnect the EGR valve harness connector (Illustration 8).
3. Remove the EGR valve securing bolts.
4. Remove the EGR valve and valve gasket.
5. Clean the valve mating faces.
6. To reinstall the new EGR valve and gasket, reverse the EGR valve removal process.

Note: Care must be taken not to damage the EGR valve securing bolts. Torque figure: 23–27 Nm (17–20 lb ft).

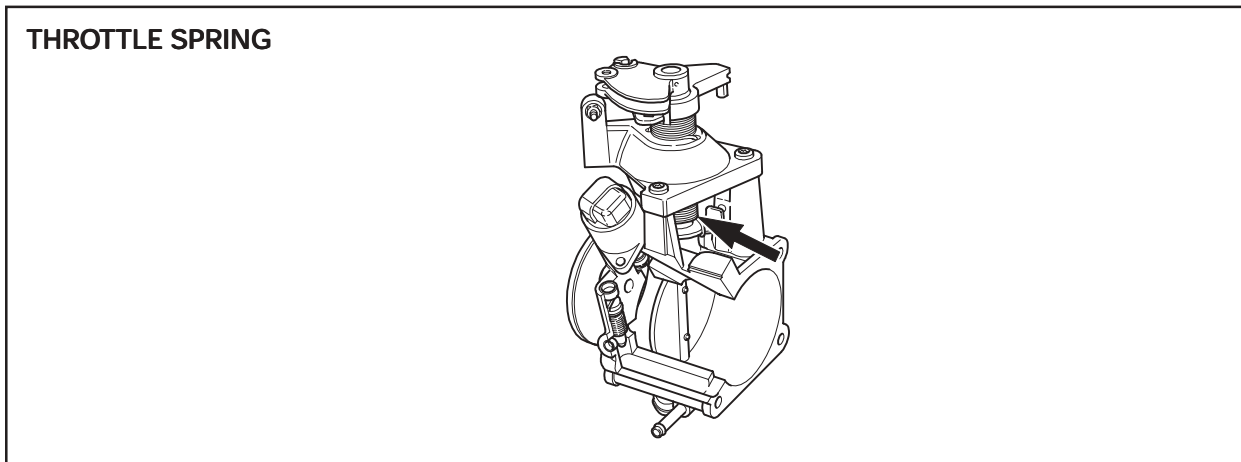
ILLUSTRATION 9

- Replace EGR valve and gasket, to ensure that it is free from contamination.
- Replace throttle return spring. Some vehicles may experience customer complaints of high idle speeds.

4. Unhook the throttle torsion spring (Illustration 9) from the throttle shaft actuator and then remove the spring and the sleeve from the shaft.

5. Remove the sleeve from the spring and discard the spring.
6. Insert the sleeve into the replacement spring. Install the sleeve and spring on the throttle shaft and hook the spring on to the actuator.

Note: The throttle return spring must be tensioned, (pre-loaded) by rotating the straight extension one full turn counterclockwise until it can be installed in the same position as the original spring.
