**Steering Rack – Leak at Transfer Pipe
Union Nut – Replace O-rings**MODEL 1997 MY-ON
XK8 Range
VIN
001001-ON**Issue:**

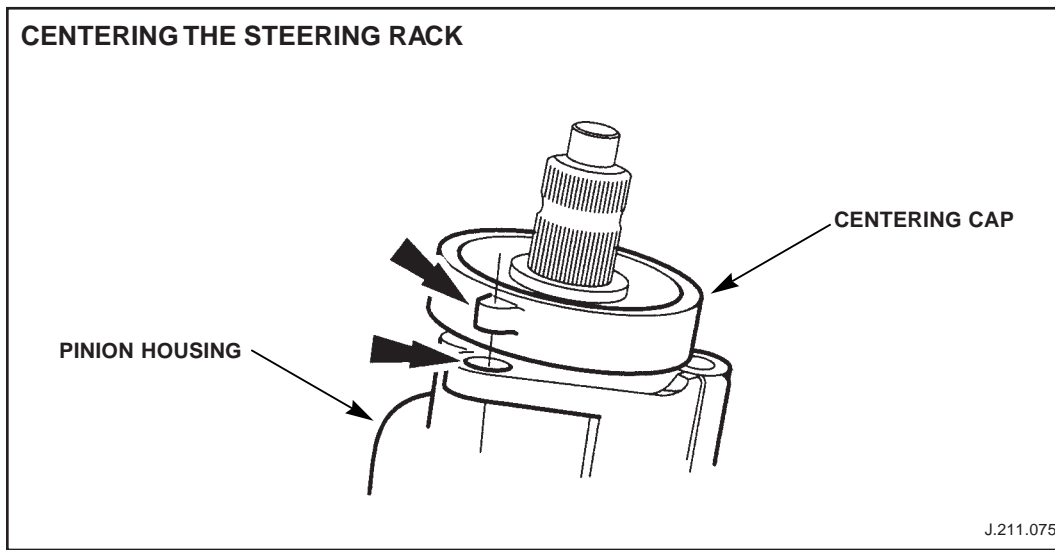
ILLUSTRATION 2

- Align the pinion centering cap with the lug on the pinion housing (Illustration 2) to precisely center the rack.
