Poor Start –  
Fuel Line Knocking Noise –  
Repair Procedure

MODEL 1998 MY  
V8 XJ Series

VIN 812256-851000

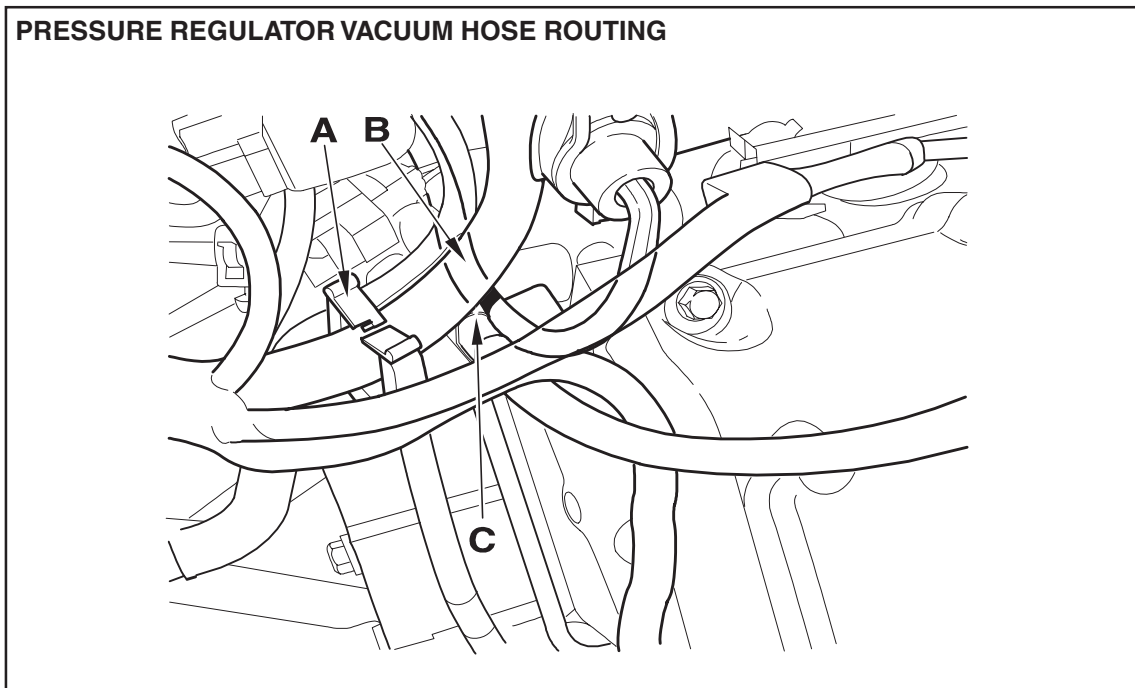
ILLUSTRATION 1

Some 1998 MY V8 XJ Series vehicles, within the above VIN range, may experience a knocking sound from the fuel line, or excessive cranking being required to restart the engine. The possible cause may be that the vacuum hose from the fuel pressure regulator to the throttle body unit is kinked or restricted due to pressure from a wiring harness.

If case of a customer complaint of fuel link knock on vehicles within the above VIN range, check for a kinked vacuum hose at the rear of 'A' cylinder bank (right side). Below and outboard of the throttle body there is a support bracket that holds clips 'A' and 'C' (Illustration 1), which locate the fuel injection and starter motor harnesses. Ensure that the vacuum hose is routed through this area in a way that it can not be kinked or restricted where it passes under the harnesses but above

Before VIN 851000, the location of harness clips 'A' and 'C' was the opposite of the layout in Illustration 1. In case this concern occurs, swap the location of these two clips to the layout for later vehicles, as shown in Illustration 1. This will provide a greater clearance between harnesses and bracket where the fuel pressure regulator hose passes between harness and bracket at 'B'.
