**Noise From Front of Vehicle –
Cooling Duct Vibration –
Repair Procedure**MODEL 1998 MY-ON
V8 XJ Series

VIN 812256-ON

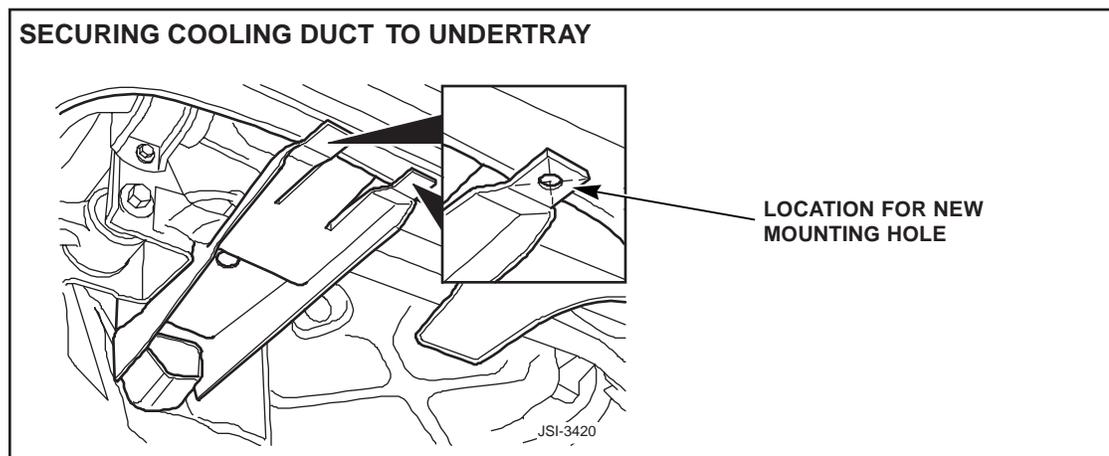
ILLUSTRATION 1

Some 1998 MY V8 XJ Series vehicles may experience a noise, when the vehicle is driven at speeds above 60 mph, (120 km/h). The noise has been identified as being caused by the vibration of the leading edge of the generator cooling duct, where it engages the undertray.

The cooling duct has three fingers on the forward edge which locate on the rear edge of the undertray. The center finger fits over the tray and the outer two fingers fit under the tray.

1. Raise the vehicle on a lift.
2. With the cooling duct and the undertray in position, mark the centers of the overlapping portion of the outer two fingers (Illustration 1).
3. Obtain two plastic rivets (part no. KRA 106001).

4. Drill two holes through the undertray and the duct at the centers (Illustration 1), large enough to provide clearance for the rivets.
5. Install the rivets to secure the duct in position.
