SERVICE

TECHNICAL BULLETIN

Poor Drivability/MIL Illumination –
Check Throttle Synchronization

MODEL	1995 MY XJ12 Sedan
VIN	720001-ON

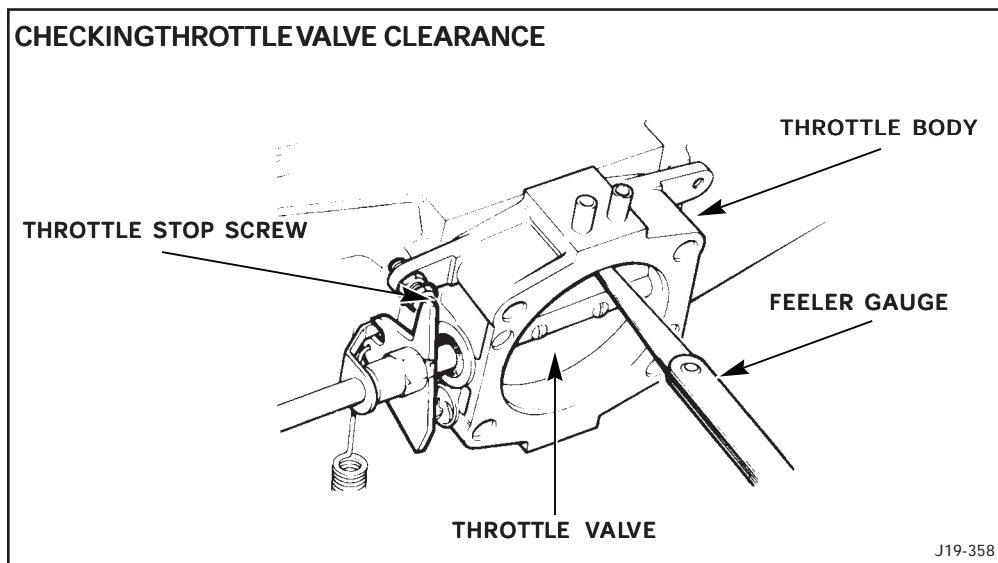
ILLUSTRATION 1

1. Check that both throttle valves are centered horizontally and vertically in the throttle bodies.
2. With the throttle valve closed, use a feeler gauge to check the clearance between the throttle valve and the throttle body (Illustration 1).

Throttle valve checking clearance: 0.001 - 0.003 inch (0.025 - 0.076 mm)

Check the clearance at the bottom as well as at the top of the throttle valve. If a significant difference is found between the top and bottom measurements, the throttle valve may be offset on its shaft. If both measurements are within the above range, do NOT adjust the throttle stop screw (Illustration 1).

3. If adjustment is necessary, set the throttle stop screw to achieve the following throttle valve clearance range:

Throttle valve setting clearance: 0.001 - 0.0015 inch (0.025 - 0.04 mm).

After completing throttle valve adjustment, seal the locknuts with a dab of paint.
