**Door Lock Mechanism – Tight
Operation – Modification Procedure**MODEL 1995-96 MY
Sedan Range

720001-ON

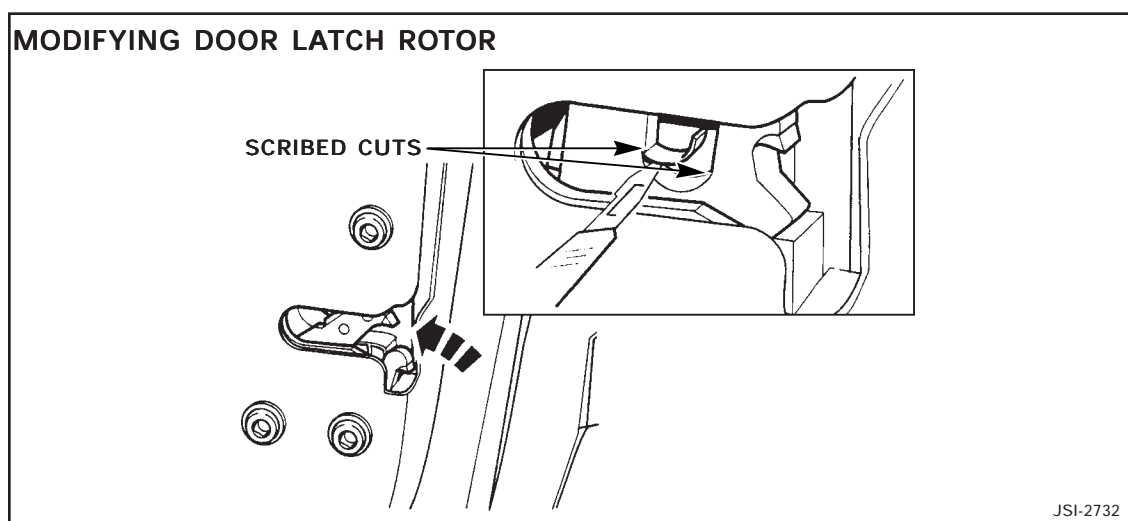
ILLUSTRATION 1

Some 1995 MY-ON Sedan Range vehicles may exhibit tight operation of the door lock mechanism. This condition has been found to be caused by the plastic coating on the latch rotor.

1. Use a screwdriver to move the latch rotor into a partially closed position as shown in Illustration 1.
2. Refer to Illustration 1 and use a sharp knife to scribe two cuts across the width of the latch rotor at each end of the curved portion.

3. Cut away and remove (in one piece, if possible) the curved portion of the plastic coating between the two scribed cuts (Illustration 1). Plastic should only be removed from the curved area of the latch rotor, not on the straight sections. Do not allow the removed pieces to drop into the lock mechanism.

CAUTION: Do not use hand files, rotary grinders or similar tools for this operation, since debris can fall into the lock.
