By EZDriver of Holly Lake Ranch, Texas

Hello to one and all. Thought I would share my experience with pics of replacing the 2nd generation cam chain tensioners with the new metal tensioners the third generation. This instruction is in support of "2nd tensions DIY instructions by sininnellen listed below. This information is also in two parts due to the number of pics. The first part, this part, is mostly for the purpose of showing the pics of the inside where the parts are replaced. The second thread will show pics and discuss the problems I ran into with solutions.

Procedure by EZDriver

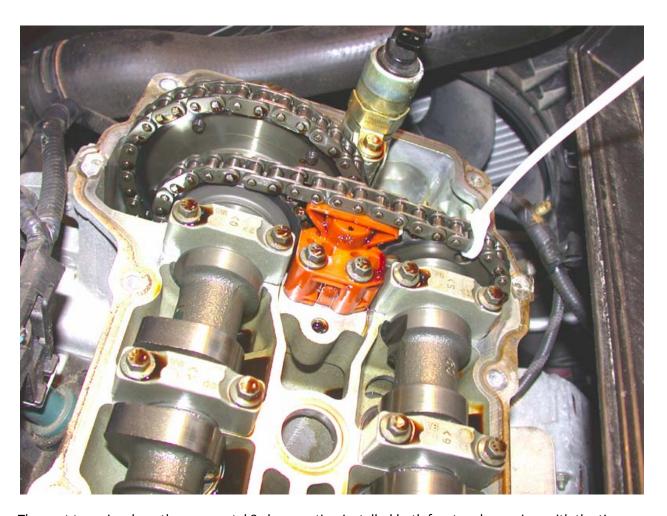
The first three pics are of the right bank. First pic shows what it looked like initially but with the tie wrap installed on the exhaust cam sprocket and chain. This is with the 2nd generation tensioner still installed.

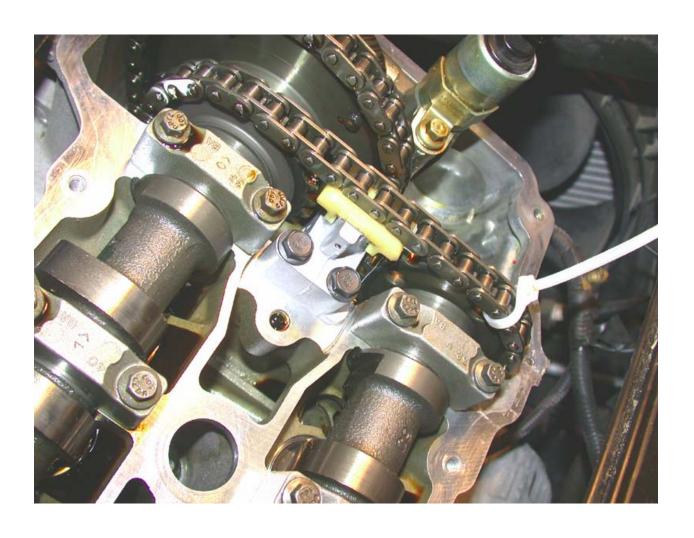
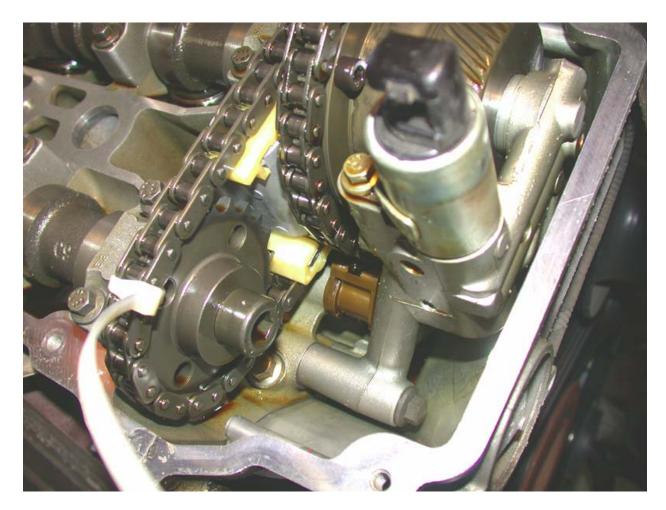
The next two pics show the new metal 3rd generation installed both front and rear view with the tie wrap still installed. Don't forget to remove the tie wrap.

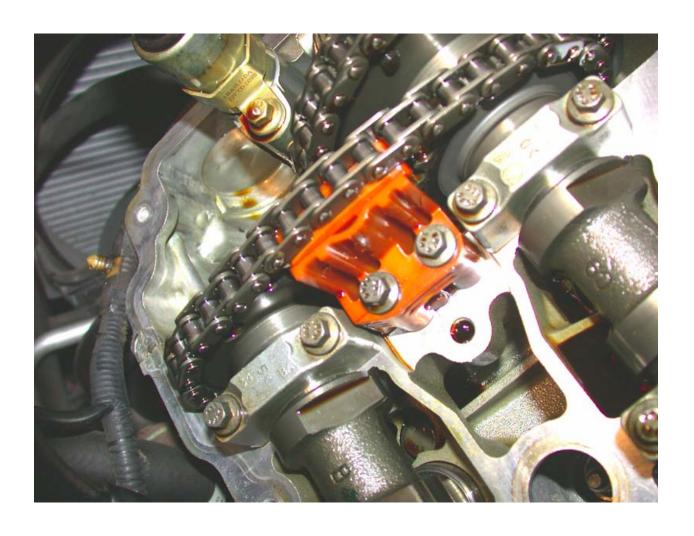
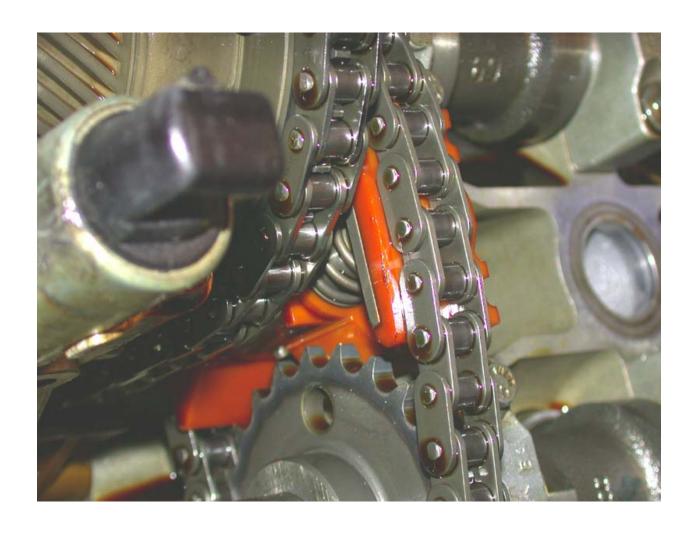
The next set of pics are of the left bank with the first three showing the as was installation, 2nd generation still in place. The next two show the new metal version installed both fore and aft. These last two also show a shop rag jammed in the big hole up there. I thought that was a good idea to avoid any parts falling down the big hole. I did that on both sides. Removing the old tensioners is not a concern here in that they stay in one piece due to the oil in the piston causing a suction that keeps them from falling apart. But, on the right bank you have to remove the red <u>safety</u> pin that holds the new tensioner together before you can install it. Therefore you have to hold it together as you place it. On the left bank you can leave the red pin in place as it is installed. See next to last pic. Just don't forget to remove it. Also the new tensioners are different left to right. They are labeled LB and RB.

The last pic is the only one that shows the cam caps removed. Also the first pic of the left bank shows a tie wrap holding the oil dip stick out of the way. That worked good.

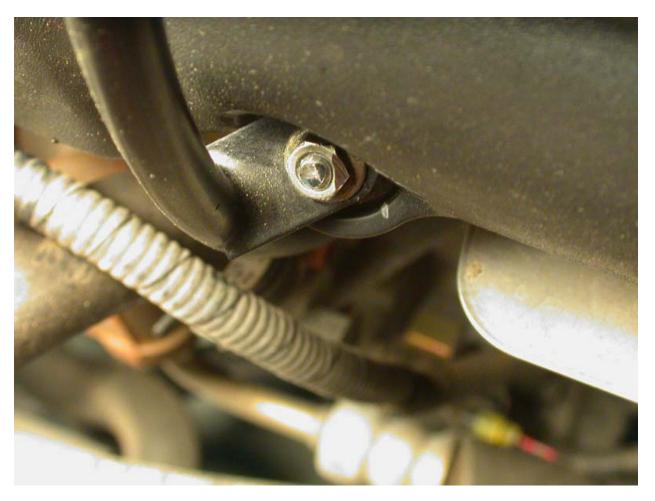
On the left bank cam cover removal I hit a real snag and almost gave up. I was told to remove the oil dip bracket nut and gently lift the dip stick bracket off the cam cover nut/stud which is about an inch or more long. I don't think that is possible. At least I'm not strong enough. And I know of one local mechanic that broke that bracket trying to gently lift the bracket off the stud. I was stuck. So I do what I always do. Sit and think. Finally I had it. I got my dremel tool out with a cut off saw blade and cut the stud off just above the nut that was still installed. Then I could gently lift the oil dip stick bracket off the stud after removing the nut. After removing the cam cover I cleaned up the stud end so the nut would easily go back on. The results of this can be seen in the first picture attached. It worked well. Just be careful with the dremel tool and don't damage the cam cover.

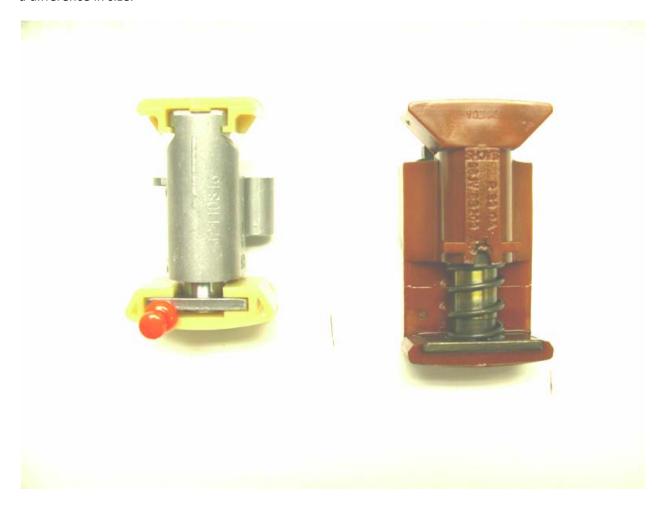
The next picture shows the comparison of the new metal tensioner with the big plastic tensioner. Quite a difference in size.

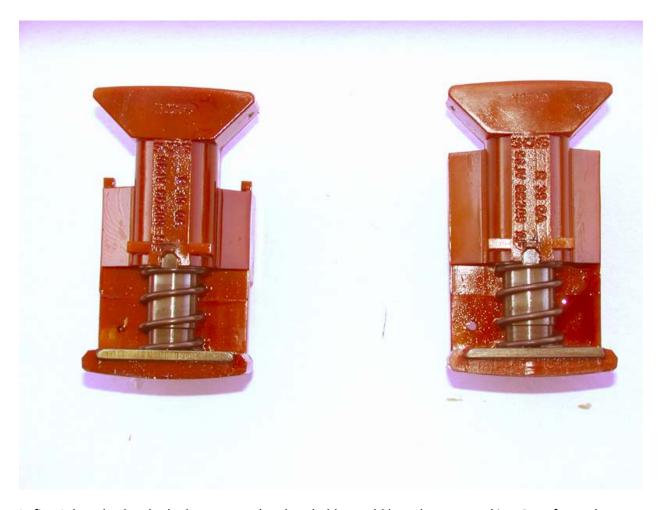
The next picture shows the two removed plastic tensioners.

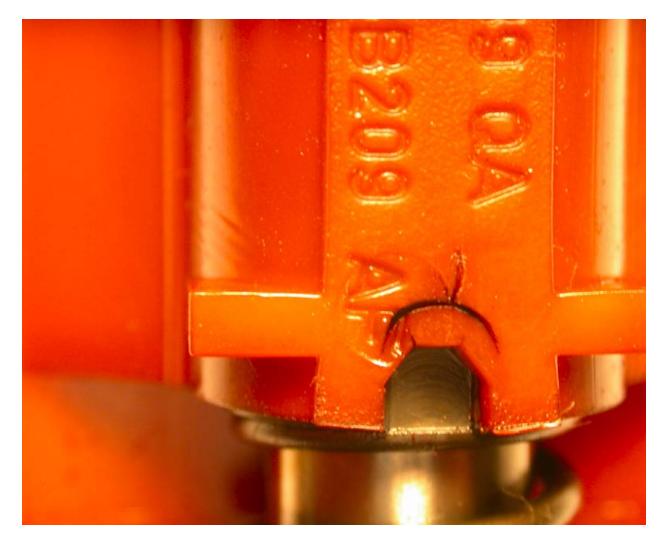
At first I thought they looked pretty good and probably would have kept on cooking. But after a close look as you get in the last picture cracks were starting just above the notch cut out at the bottom of the barrel. As you can see in the picture the cut out has sharp corners that cause stress concentration in that area which in turn causes fatigue cracking.

That is exactly what is happening. These upper tensioners are subject to side load especially during engine start up. Why the notch cut out? I don't know but it sure was a stupid idea and probably ruined a good part.
