**S-TYPE**

S303-12

SERVICE**TECHNICAL BULLETIN**

Misfire/Non-Start –
Water Ingress Into Spark Plug Wells –
Revised On-Plug Coil Cover

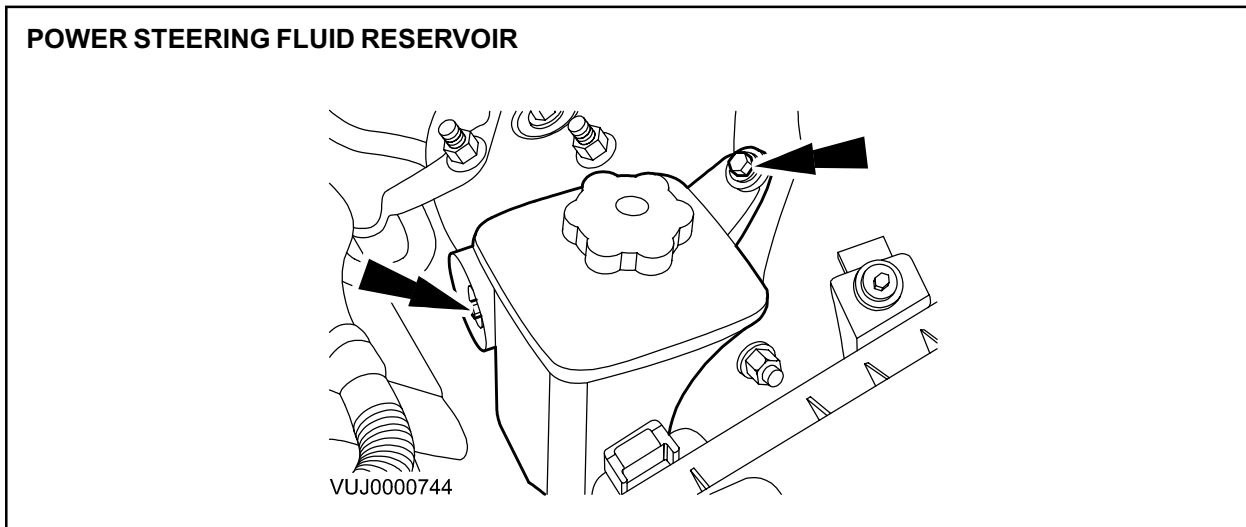
ILLUSTRATION 1

7. Remove the power steering fluid reservoir securing screws and displace reservoir (Illustration 1).

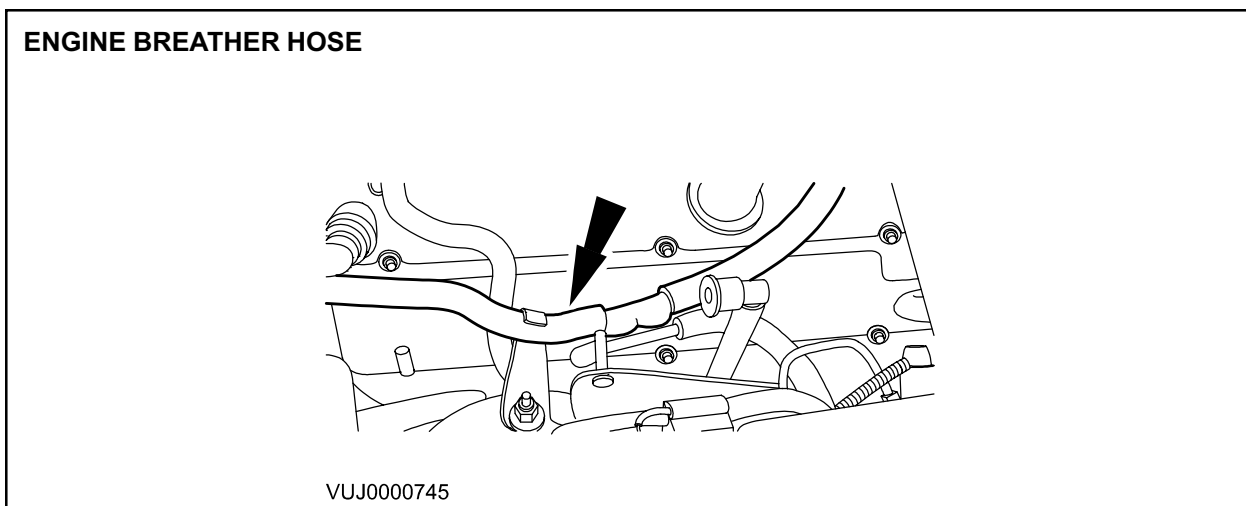
ILLUSTRATION 2

8. Release engine breather hose from securing clip (Illustration 2).
