19.7-04

TECHNICAL BULLETIN

Clicking Noise From Front of Vehicle – Brake Disc Dust Shield – Install Revised Dust Shield MODEL 1995-96 MY Sedan Range VIN

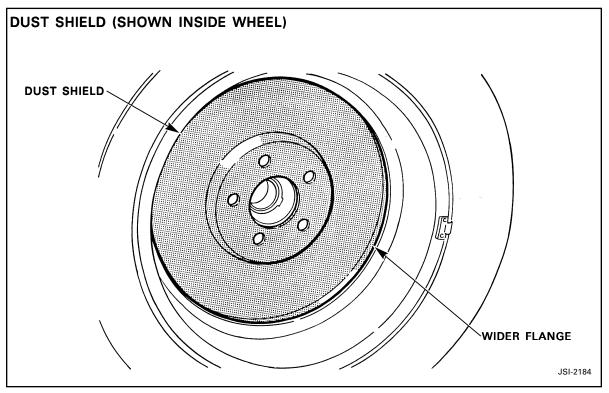
ILLUSTRATION 1

Some 1995-96 MY Sedan Range vehicles equipped with 16 inch alloy wheels **and** accessory dust shields (Illustration 1) may experience a clicking noise from the front of the vehicle at low speeds. The noise may be caused by one dust shield rubbing against the alloy wheel.

After verifying a customer complaint of clicking from the front of the vehicle, determine on which side of vehicle the noise is apparent. Replace the dust shield on that wheel with a revised dust shield. In addition to the part number label, the revised dust shield can be identified by a wider flange with foam rubber blocks attached.
